Intermediate Temperature Stress Rupture of Woven SiC Fiber, BN Interphase, SiC Matrix Composites in Air

Gregory N. Morscher
Case Western Reserve University, Cleveland, Ohio

Prepared under Contract NCC3-404

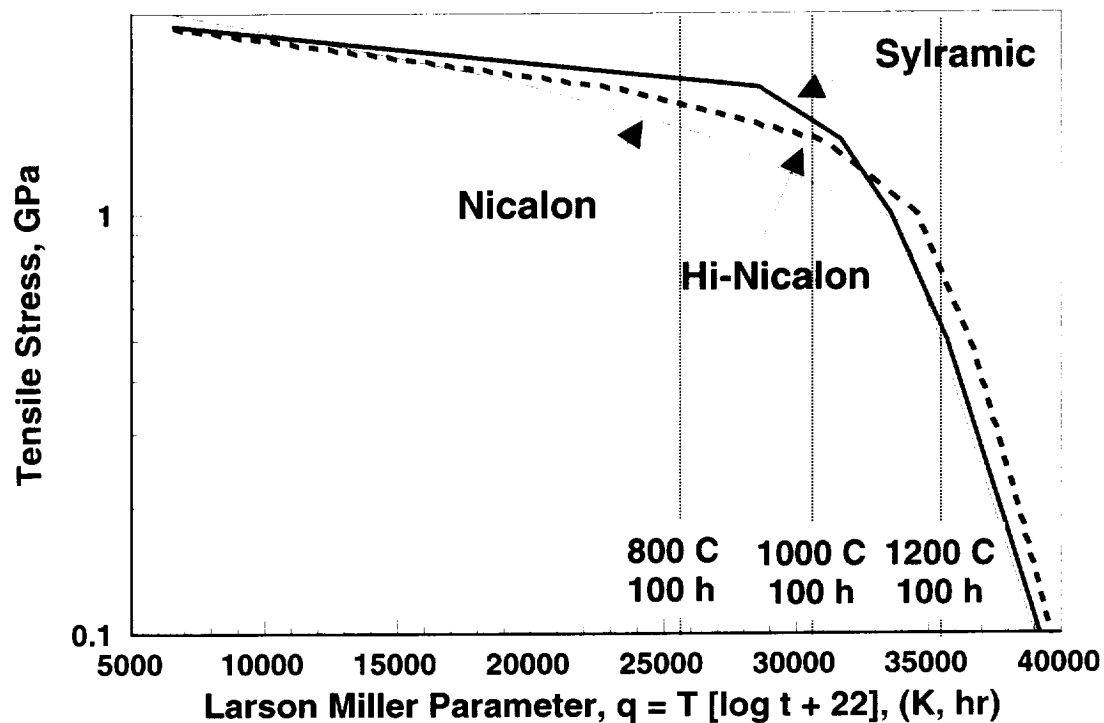
Figure 1.1: Larson Miller plot for the rupture properties of Hi-Nicalon and Sylramic fibers (from ref. 12 and 13).

The shallow slope at lower temperatures of the fiber rupture curves in Figure 1.1 is indicative of a slow crack growth type of mechanism; whereas, the steeper slope at higher temperatures more likely corresponds to a creep-rupture type of mechanism^[14]. The benefit of this type of plot is that all of the rupture behavior can be plotted over the entire temperature range. This will allow a comparative approach when analyzing composite performance, as will be discussed more fully in later sections. Comparing the properties of the fibers to that of the composites helps to reveal, the time-temperature ranges where mechanical properties are controlled by the fiber properties themselves versus some other embrittlement mechanism.

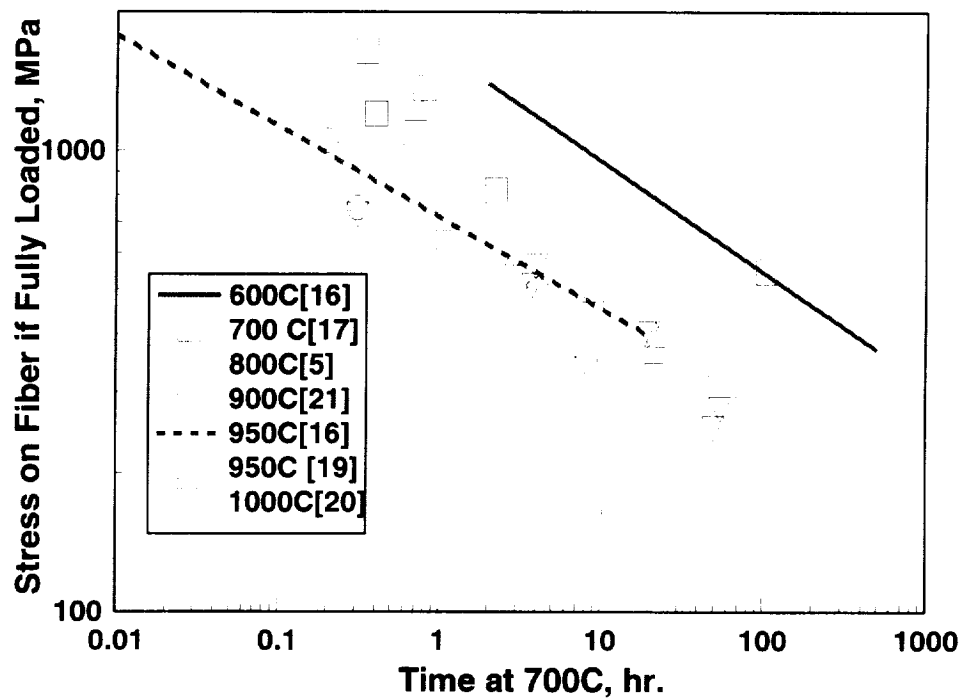
Figure 1.2: Stress rupture of Nic/C/SiC composites. Data from Lin et al. [16] are from 4-point flexure tests. The other data are from tensile tests.

Some rupture properties have been determined for composites of Nicalon fiber, with a carbon interphase and a CVI SiC matrix (Nic/C/SiC). For example, Heredia et al.^[15] performed stress rupture experiments in air at 800°C on 2D woven Nic/C/SiC composites and found a drastic reduction in rupture strength as a function of time. Analogous behavior was found for similar composites at 600 and 900°C by Lin et al.^[16], and at 700°C by Morscher^[17] for single tow minicomposites, at 425°C by Lara-Curzio^[18], at 950°C by Lara-Curzio^[19], and at 1000°C by Lipetzky et al.^[20]. Steyer et al.^[21] and Verilli et al.^[22] have also determined the stress rupture properties of a NiC/C/SiC which has an “enhanced” (B₄C-containing) CVI SiC matrix over similar temperature ranges. Most of the data for these studies are compiled in Figure 1.2 and on the Larson-Miller plot in Figure 1.3. In constructing this plot (Fig. 1.3), the stress on the fibers was determined by the composite stress divided by the volume fraction of fibers in the loading direction since failure is at the region immediately associated to a matrix crack. Such normalized data facilitates a direct comparison with single fiber rupture data (Fig. 1.3).

The data appear consistent with temperature, despite the fact that the tests performed by Lin et al.^[16] were in 4-pt flexure and the other tests were in tension. The lifetime of the flexure specimens must have been controlled by the behavior on the tensile face. It is clear from Figure 1.3 that the rupture behavior of these composites are far worse than would be expected for the as-produced fiber properties.

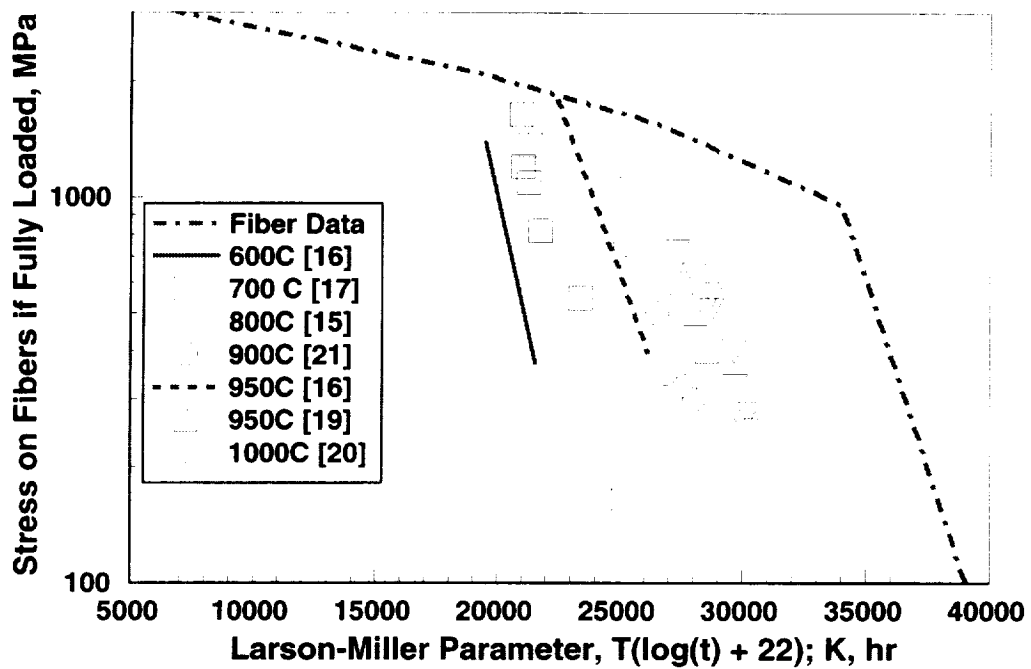
Figure 1.3: Larson-Miller plot for Nic/C/SiC data and as-produced Nicalon fiber data [12].

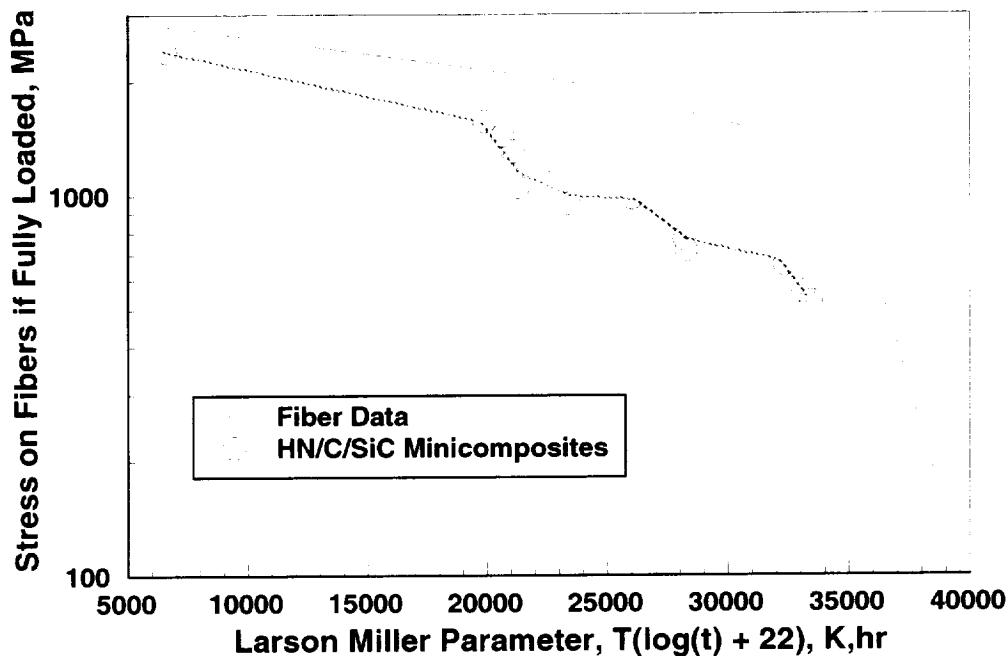
Figure 1.4: Larson Miller plot for HN/C/SiC minicomposite rupture and as-produced Hi-Nicalon fibers [26].

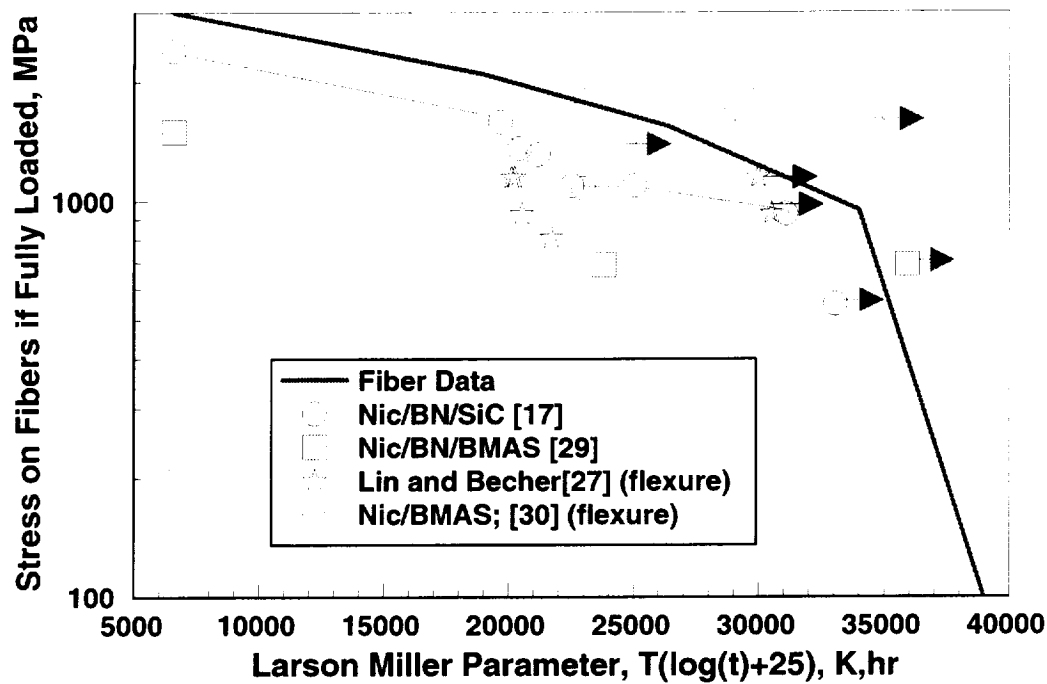
Figure 1.5: Larson Miller plot for Nic/BN/SiC minicomposites and as-produced Nicalon fibers.

Flexural data from Lin and Becher^[27] is plotted in Figure 1.5 for Nic/BN/SiC. Similar embrittlement to the tensile data was observed for low temperature (600°C) conditions and short-time higher temperature (950°C) conditions. For longer times at 950°C, run-out occurred due to matrix crack sealing.

Also plotted on Figure 1.5 is data from Brennan^[32] for two tensile stress-rupture tests performed on a Nicalon fiber, BN interphase, BMAS glass ceramic composite. Even though this is a different matrix system, it is interesting to note that the rupture behavior of the intermediate temperature rupture condition (900°C; 6269 hrs) was what would be expected from the minicomposite results (i.e. if the rupture strength data for both the BMAS and minicomposites were normalized by the room temperature strength they would fall on the same curve). In what might at first be surprising, the higher temperature rupture condition (1200°C for ~ 1.6 years) never failed. But, although the temperature is increased, favoring kinetics, the system became isolated from the environment because the matrix undergoes a phase transformation at the higher temperature that results in any matrix cracks being sealed. At 900°C, sealing did not occur and the environment had access to the fiber and interphase.

Flexural stress-rupture data is also plotted on Figure 1.5 from Sun et al^[33] for the same system as ref. 30. There was a decrease in rupture strength; however, not as severe as for the tensile stress-rupture condition.

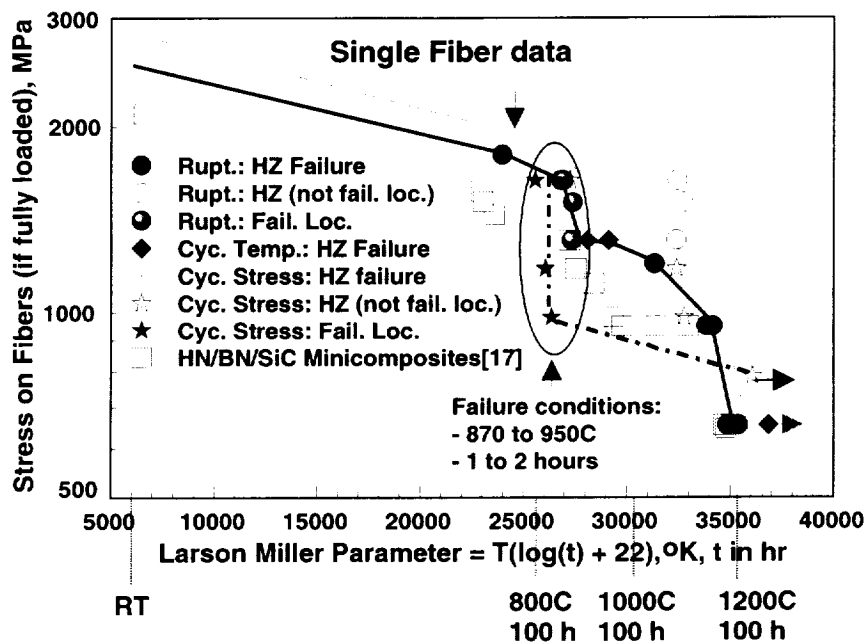
Figure 1.6: Larson Miller plot of HN/BN/SiC minicomposites and as-produced HN fibers in air. All of the data is from ref. 28 except where noted.

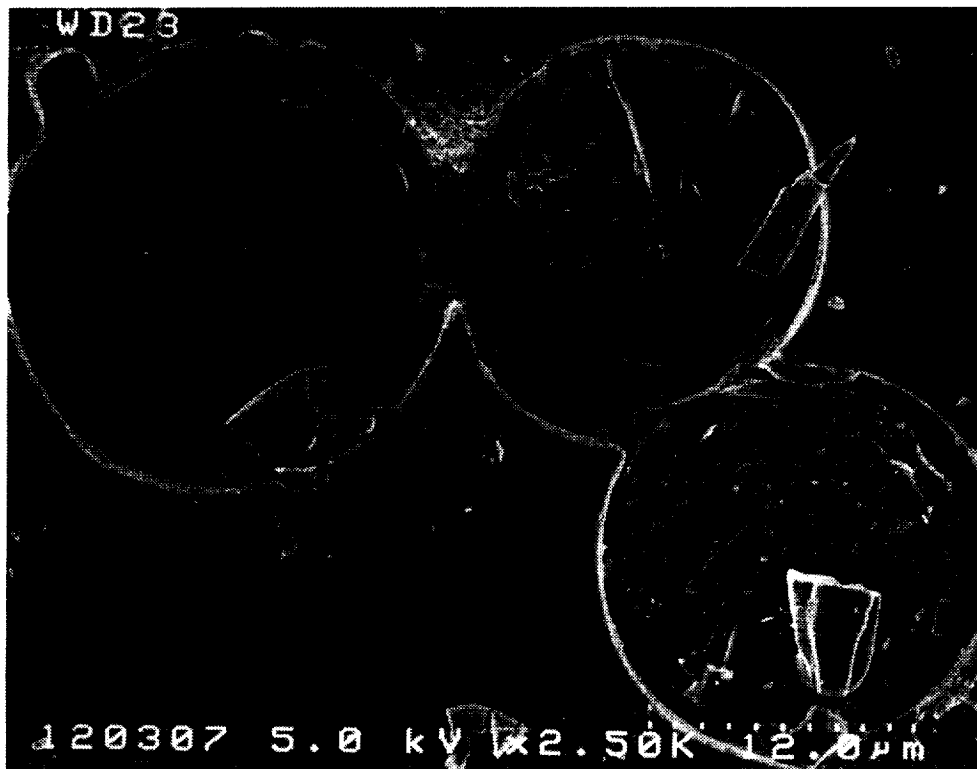
Figure 1.7: Portion of a HN/BN/SiC minicomposite fracture surface after 900°C rupture^[23]. Note gap between fiber and matrix and glass fusing fibers together or fiber and matrix together.

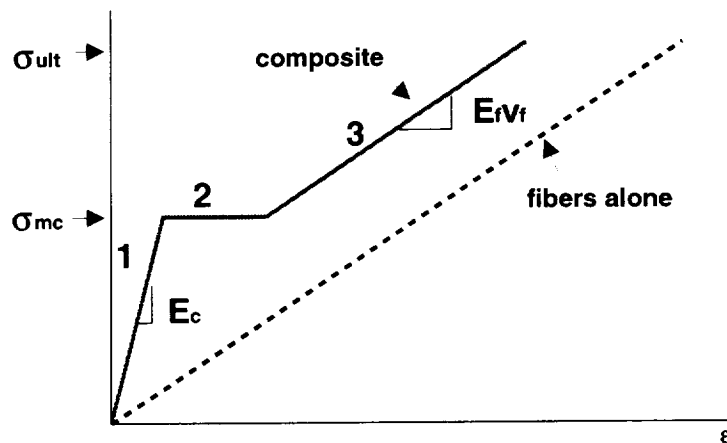
Figure 1.9: Stress-strain curve of a unidirectional composite based on ACK^[28] theory.

The reason for the non-linear stress-strain behavior in CMC's is because of damage accumulation in the composite (matrix cracking). The classic work describing the non-linearity of the stress-strain curve was by Aveston, Cooper, and Kelly (ACK)^[34]. ACK showed that if the fiber elongation is greater than that of the matrix and if the fibers are able to sustain the extra load applied when the matrix fails, non-linear stress-strain behavior will result. Figure 1.9 is a representation of the ACK theory.

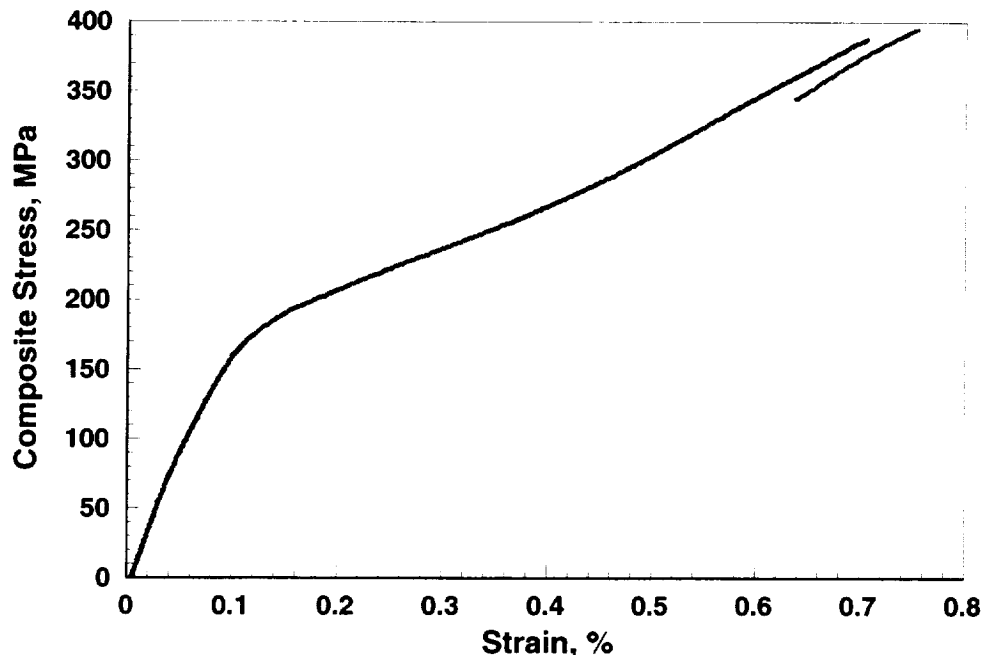
Figure 1.12: Monotonic and hysteresis loop performed on two different samples from the same HN/BN/MI composite.

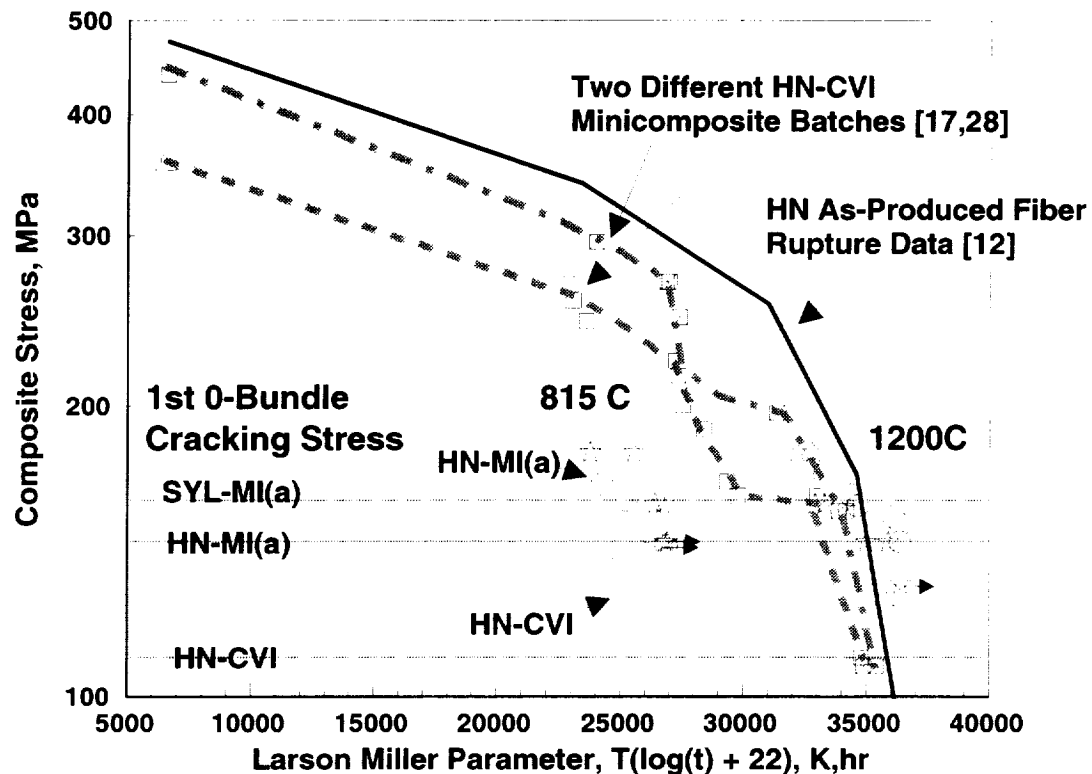
Figure 1.14: Larson Miller plot showing rupture properties of fibers and minicomposites, LCF properties of macrocomposites, and the 0° onset-cracking stress for macrocomposites.

This onset of 0° cracking can be related to the stress-rupture or LCF properties for SiC/SiC composites. Figure 1.14 shows the 0° onset-stress for several systems and the LCF data at 815 and 1200°C plotted on a Larson-Miller plot. It is evident that the run-out condition for LCF (500 hours) corresponds to the 0° crack-onset stress. The implication is that in order for these composites to fail, the 0° fiber bundles must be accessed by the environment through the matrix cracks.

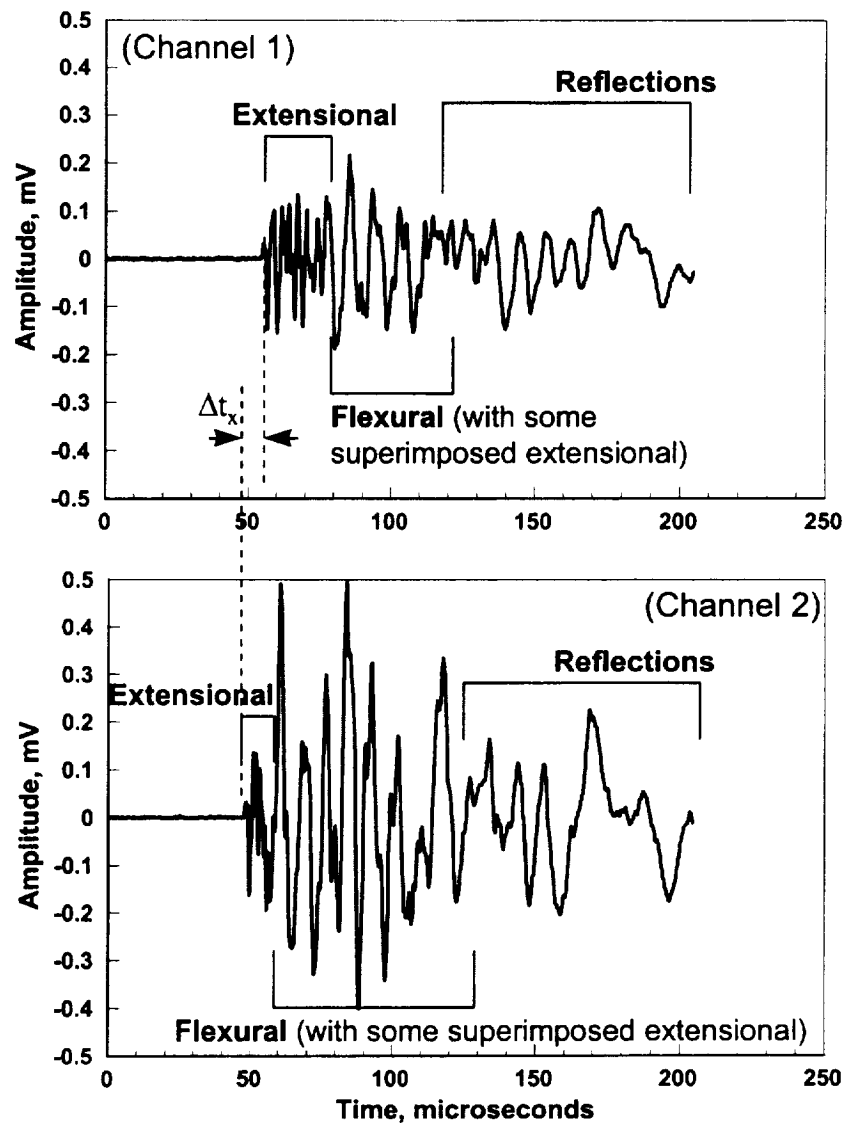
Figure 1.15: AE waveforms received on two channels (sensors) 65 mm apart from a lead break performed outside of both sensors on a Hi-Nicalon reinforced, standard CVI SiC matrix composite.

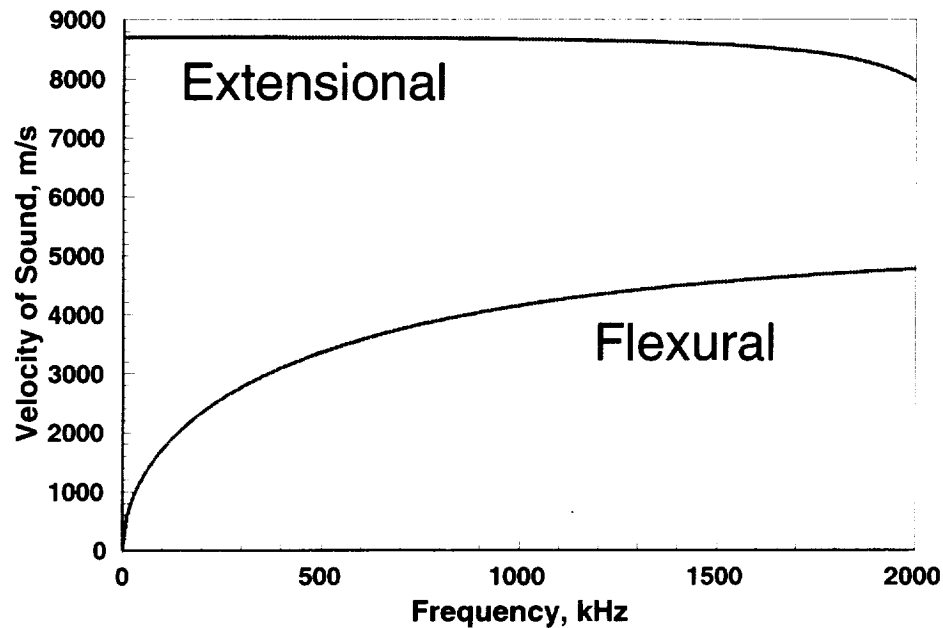
Figure 1.16: Dispersion curve of the phase velocity for the different modes of a waveform calculated from isotropic plate theory ($E = 200$ GPa and $\nu = 0.15$).

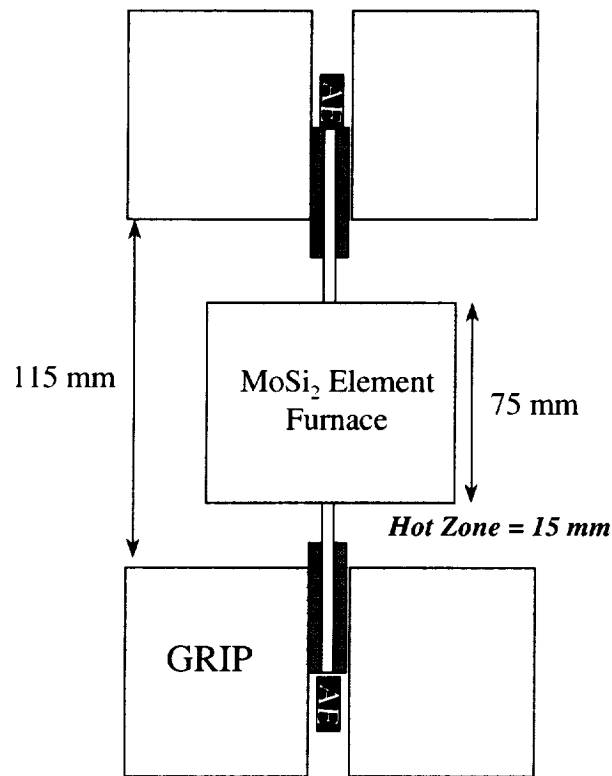
Figure 2.1: Schematic representation of the tensile test set-up.

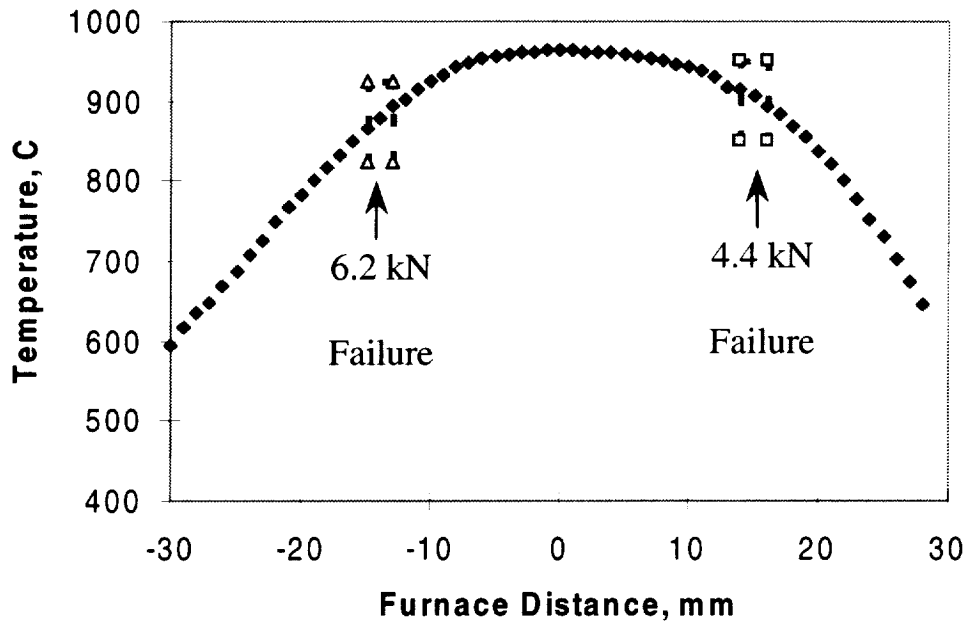
Figure 3.2: Furnace profile and location of failure for first two stress-rupture experiments.

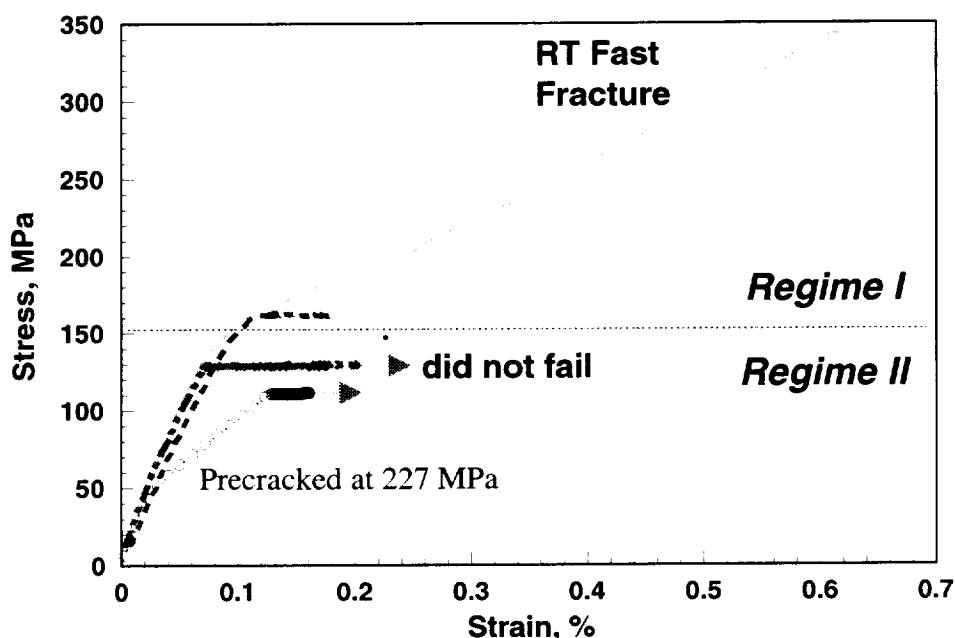
Figure 3.3: Stress-strain behavior of material tested at room temperature fast fracture and for several rupture tests. Note that the apparent load drops in the RT fast fracture curve are actually associated with unload/reload hysteresis loops which have been removed from the stress-strain curve for clarity. Also, the failure location of the RT fast fracture specimen occurred in the grips; therefore, the ultimate strength is greater than the failure stress shown in this figure.

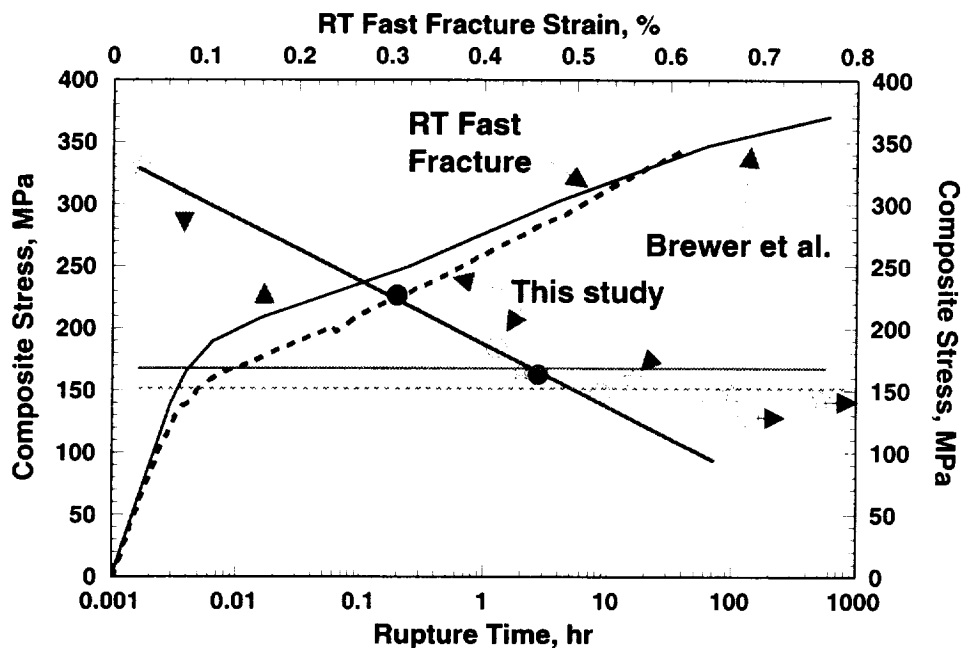
Figure 3.4: Room temperature and time dependent stress-rupture behavior of the two different Hi-Nicalon, BN interphase, MI SiC composites. For both samples tested at room temperature, failure occurred in the grips and not in the gage section. There is actually little difference in the ultimate properties of these two composites.

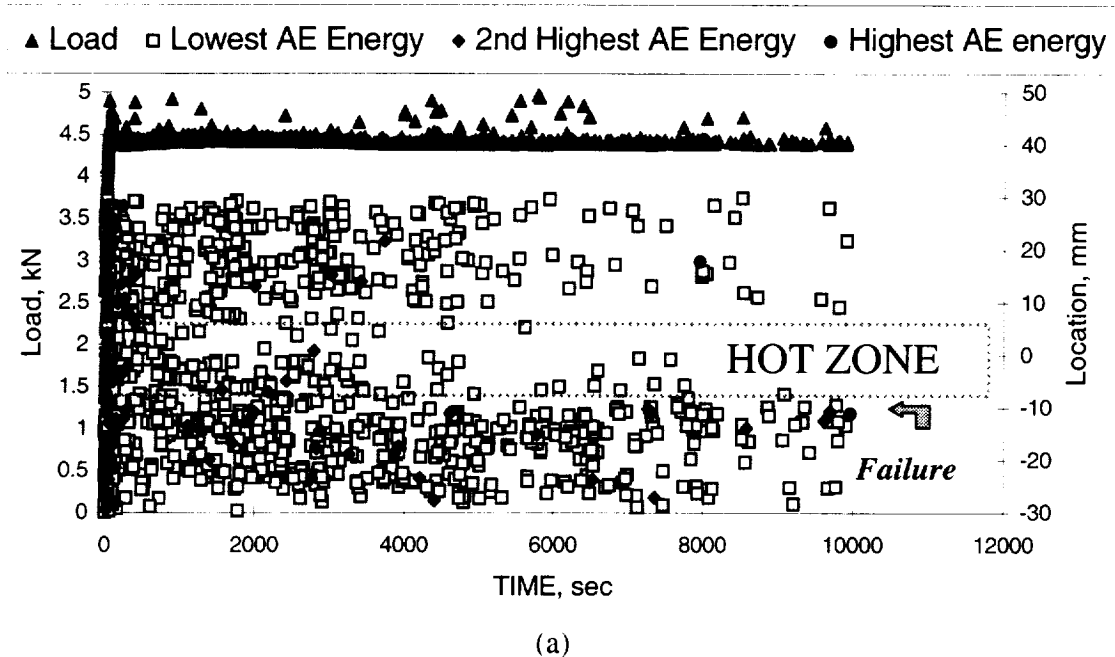
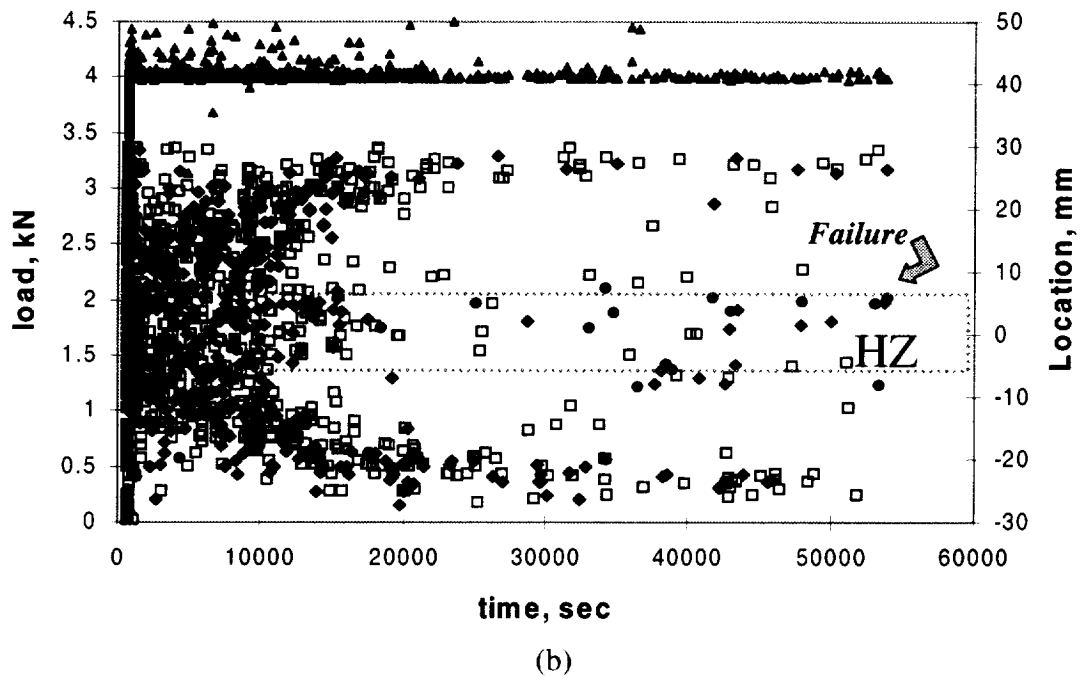
Figure 3.6: Load and AE event location versus time for (a) an applied load of 4.4 kN (160 MPa) at 960°C hot zone temperature and (b) an applied load of 4 kN (148 MPa) at 815°C hot zone temperature.

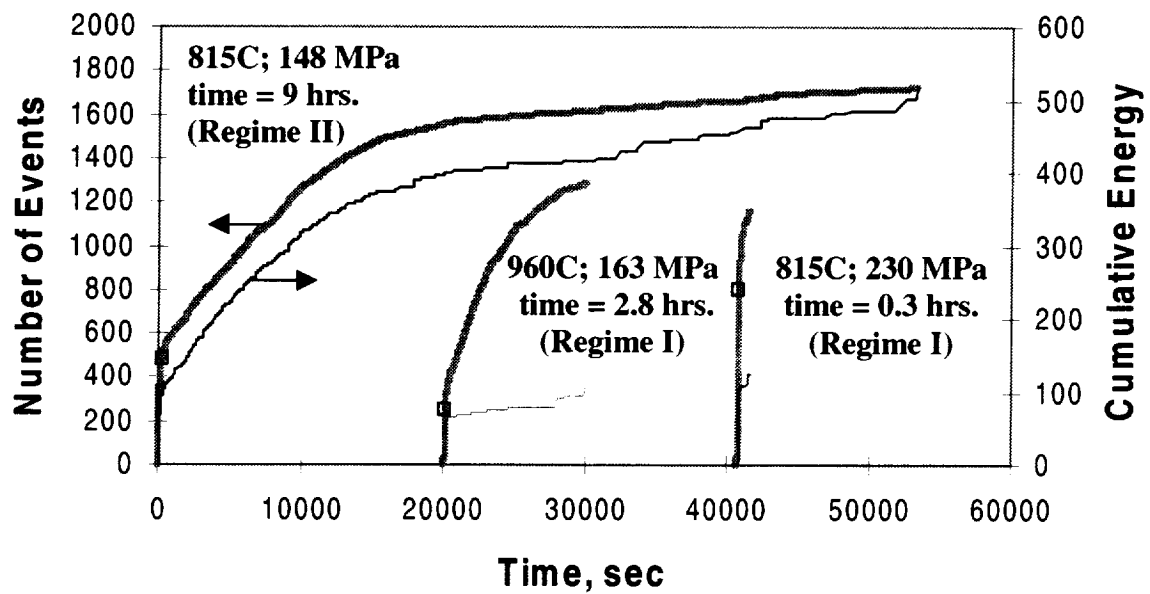
Figure 3.7: The cumulative number of AE events and cumulative AE energy as a function of time for three rupture specimens. The square on the “number of events” curves indicates the time at which the load reached the set-load for the rupture experiment. The two shorter time experiment data sets are offset on the time scale for clarity.

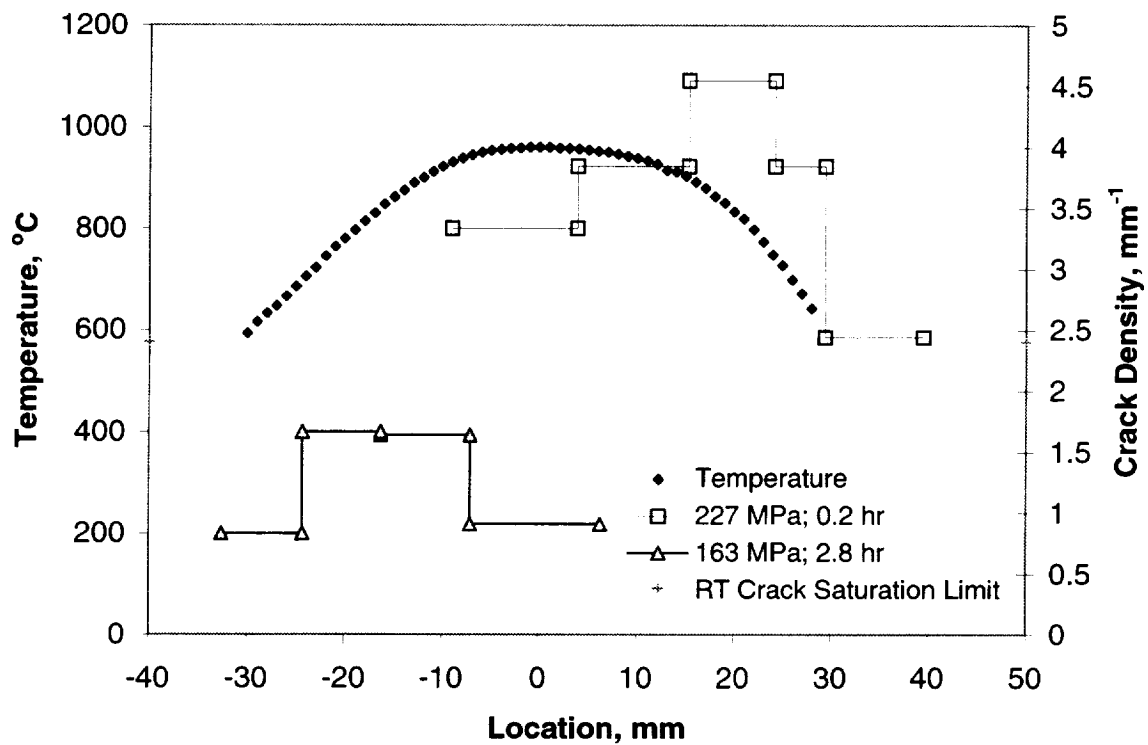
Figure 3.8: Measured matrix crack density for two samples tested at 960°C over the length of each sample as well as the furnace temperature profile as a function of length.

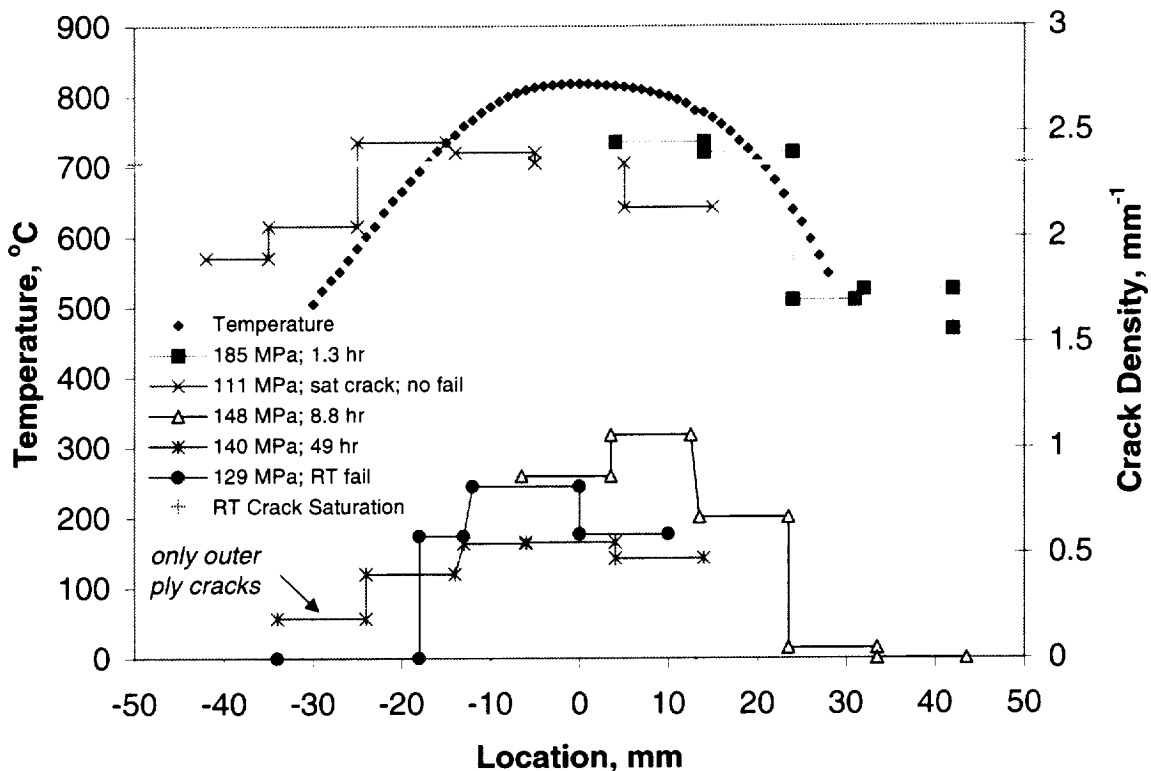
Figure 3.9: Measured matrix cracking for a sample tested at 815°C over the length of the sample as well as the furnace temperature profile as a function of length.

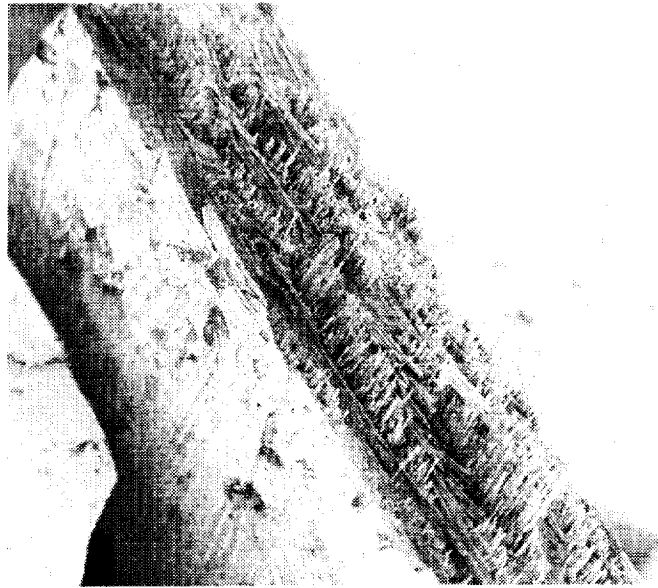
Two representative fracture surfaces are shown in Figures 3.10 and 3.11 from Regimes I and II, respectively. The fracture surface of the Regime I tested specimen (Figure 3.10) is characterized by a “picture frame” type of appearance [14]. The outer layer of tows on the face and edges of the cross-section have little or no pull out whereas the interior fibers have all pulled out. The outer embrittled tows still have BN surrounding most of the fiber except where fibers are in near contact to one another (Figure 3.10b). The oxidation reactions occur first at the fiber/BN interphase probably enhanced by the presence of a thin carbon layer on the fiber surface resulting from the high temperature MI process temperature [4,5]. Since fibers are separated by only a fraction of a micrometer, the larger BN surface area exposed to the environment results in a greater amount of BN volatilization and oxide formation [6] in these near contact regions. Every fiber fracture mirror is observed to emanate from these near fiber contact regions (Figure 3.10b). A similar observation was made for Hi-Nicalon/BN/CVI SiC minicomposites tested at slightly higher temperatures (900 to 1050°C) [7,8] where fracture mirrors emanated from fiber-matrix bonds formed by the solidified oxidation product. For the fracture surface shown in Figure 3.10a, approximately ten tows were embrittled which corresponds to ~ 19 % of the load-bearing tows. For another sample tested at 165 MPa and a rupture time of 2.8 hours with the same type of picture frame appearance, eighteen tows were embrittled corresponding to ~ 34 % of the load-bearing tows.

Figure 3.10: (a) Fracture surface of Regime I rupture fracture surface tested at 185 MPa and the rupture time was 1.3 hours. (b) Higher magnification region showing embrittled fibers.

EDS analysis was performed on the fracture surface shown in Figure 3.10 (Region I). The time to failure for this specimen was only one hour. The O:C ratio for pulled out fibers was $\sim 0.25 \pm 0.01$ from three different bundles. The O:C ratio for embrittled fiber fracture surfaces ranged from 0.24 to 0.41 from seven different bundles. The O:C ratio for the matrix regions in and around the embrittled bundles ranged from 0.5 to 0.8. As with the Region II fracture surface, the pulled-out fibers had lower O:C ratios indicating they failed last. However, in this case there was only a small difference in O:C ratios between the pulled-out and embrittled fibers.

Probability plots from the fiber fracture mirror data for the fracture surface shown in Figure 3.10 are shown in Figure 3.13. The data is plotted as $\ln(r_c^{-1/2})$ rather than as $\sigma_{fm(T,t)}$. Figure 3.13a was the only probability plot that showed a difference in Weibull modulus, m , for the three distributions from the same fracture surface. For the other fracture surfaces, the m values varied between 2 and 4 but for a given fracture surface there was not much difference in m between the embrittled or pulled out fibers (Figure 13b). The room temperature m value was found to be 3.7. Lara-Curzio et al. [12] has shown that it is important to know the fiber area pertaining to the stress at which each fiber failed to determine accurate Weibull moduli data. Otherwise, reasonable differences in the distribution of fiber areas could lead to factors of 4 differences in the Weibull moduli when assuming a constant fiber diameter. This would be impossible for this study since the exact load each fiber failed at is unknown; however, the differences in fiber diameters can be greater than a factor of two (Figure 3.10b). Therefore, the Weibull modulus data is of limited utility. However, Lara-Curzio et al. [12] did show that the strengths determined from Weibull plots are not affected by the difference in fiber areas. Therefore, the fractographic analysis will concentrate on the relative strength data of the fiber distributions.

Figure 3.10b shows a group of fibers where each fiber is in close contact (less than 100 nm) to at least one other fiber. The close contact is due to the tightness achieved during the weaving operation and pressure applied to the weave, to maintain dimensional stability of the panel, during CVI BN infiltration [15]. In order to quantify the extent of fiber-to-fiber contact, an as-produced composite was polished and the groupings of fibers were determined for individual tows from a surface ply, the second ply from the surface, and the center ply (fourth ply from the surface). The results are given in Table 3.2.

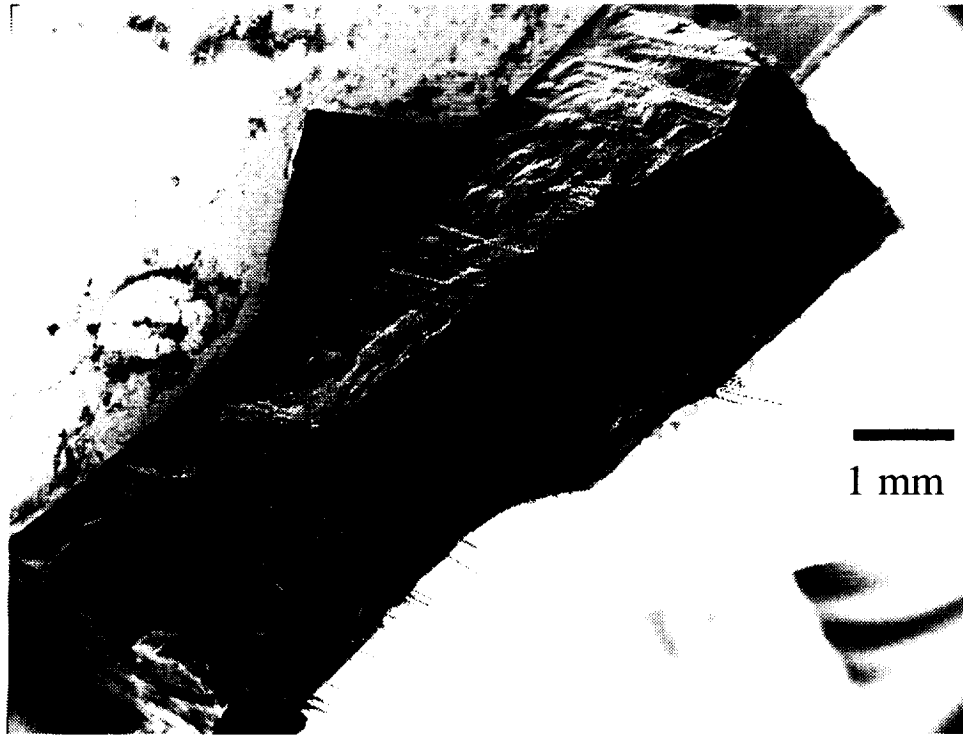
The fracture surface for the low stress regime tested specimens (Figure 3.11) is characterized by a more jagged appearance. First, the fracture takes place on several different crack surface “planes” sometimes separated by up to 3 mm in the loading direction. Second, instead of forming a picture frame, it appears these smaller local cracks grew into the interior of the sample so that some interior bundles are embrittled while some surface bundles have fiber pull out. Figure 3.11b shows a fairly sharp transition in a single tow separating the embrittled fibers from the apparently pristine fibers. Figure 3.11c also shows a typical oxidized crack surface where borosilicate liquid/glass had formed to fill the interphase regions surrounding the fibers and the crack surfaces.

Figure 3.11: (a) Fracture surface of Regime II rupture failure for fracture surface obtained from ref. 1. The applied stress was 160 MPa and the rupture time was 18.1 hours. (b, c) Higher magnification regions showing the oxidation front and region of pristine fibers.

One other possible mechanism would be the increased volume of an oxidation product formed in the matrix crack. This would act so as to wedge the crack open. Although a significant amount of oxide product is observed in matrix cracks after longer times (Figure 3.11 b and c), this mechanism is deemed least likely. In order for a solid oxide product to form and grow large enough to fill a crack would require hundreds of hours on pure SiC. A greater amount of borosilicate glass could be produced in a few hours; however it would take at least a couple of hours to remove enough boron from the borosilicate oxidation product to make it rigid enough to cause a stress on the crack tip. Even if this did occur it is expected that the oxide product would have flowed to relieve any compressive “growth” stress in the oxide product prior to rigidizing.

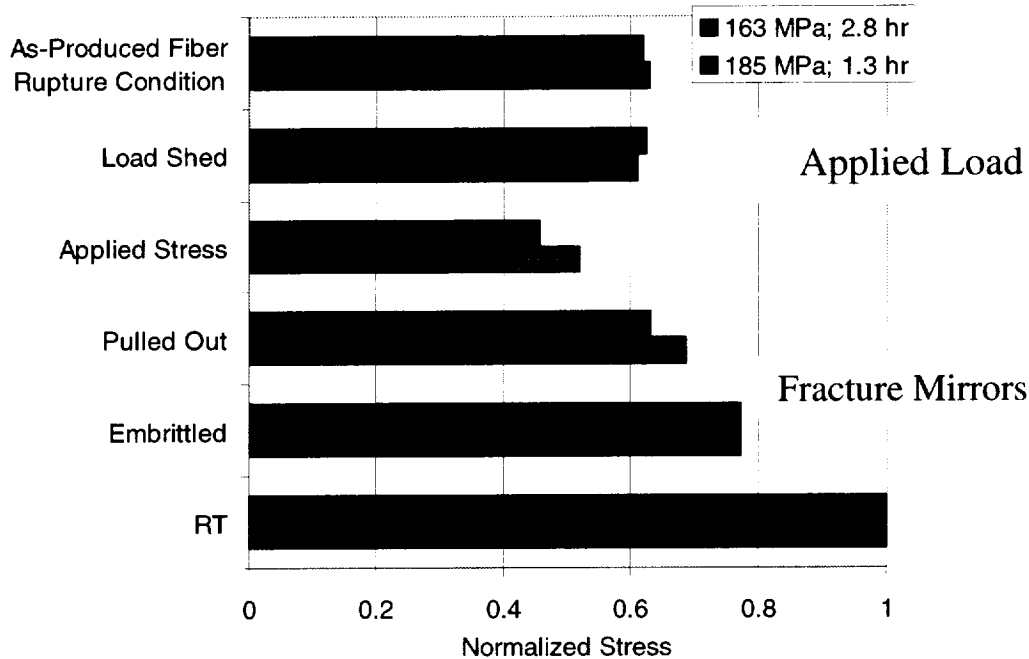
Figure 3.14: Bar charts of the normalized stress as determined from the fracture mirror analysis for two Regime I rupture specimens. Also plotted is the normalized applied stress, the normalized stress from the load shed by the embrittled fibers, and the Larson-Miller condition for fiber failure[13].

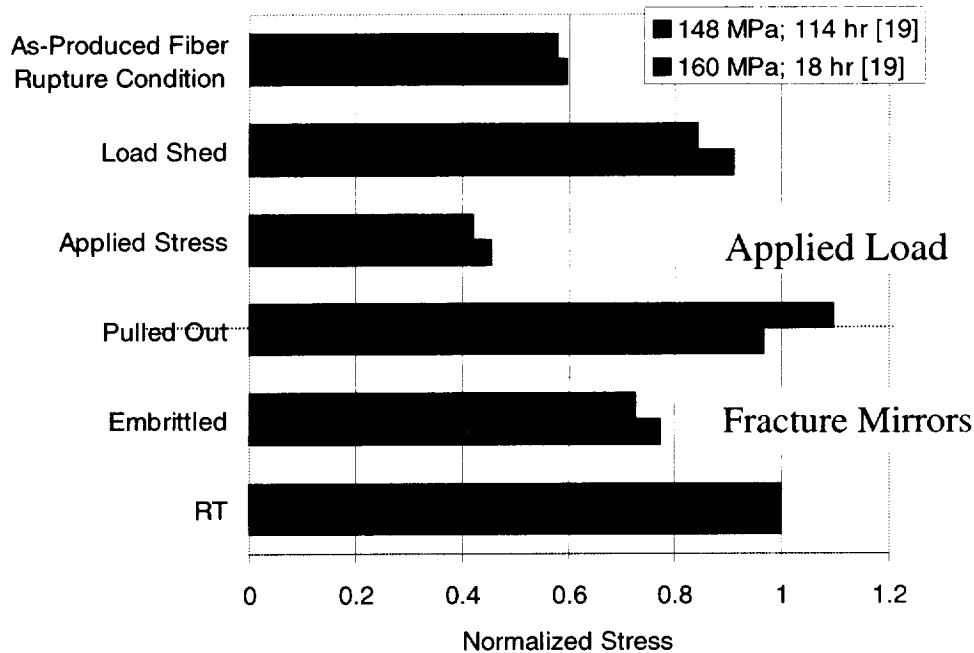
Figure 3.15: Bar charts of the normalized stress as determined from the fracture mirror analysis for two Regime II rupture specimens. Also plotted is the normalized applied stress, the normalized stress from the load shed by the embrittled fibers, and the Larson-Miller condition for fiber failure [13].

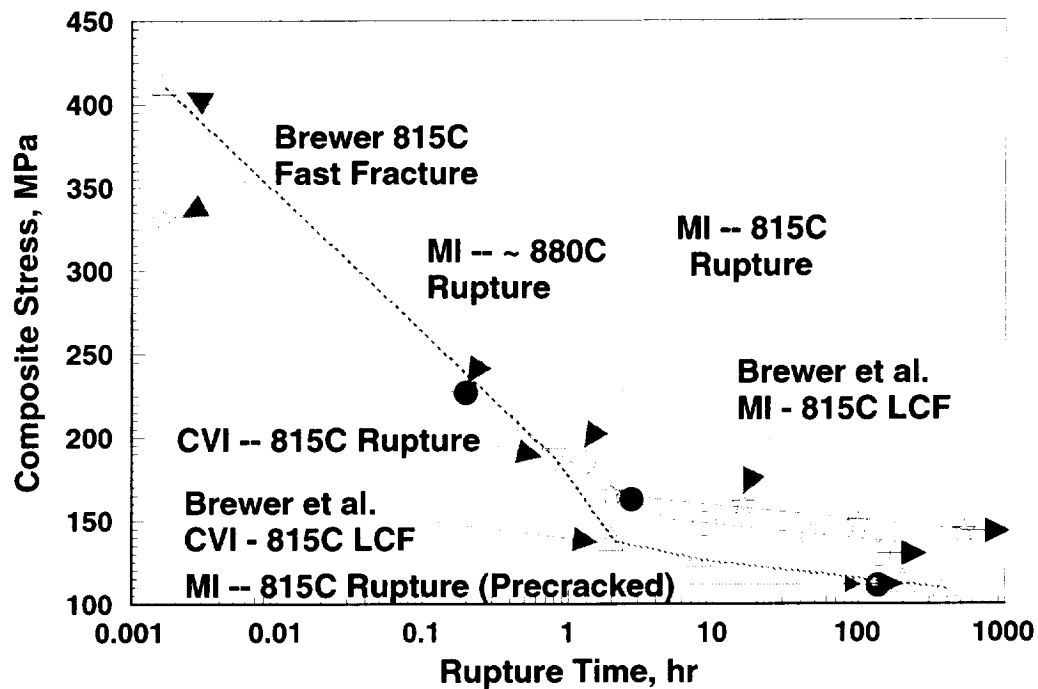
Figure 3.17: CVI matrix and MI matrix (Figure 3.1) composite stress-rupture data from this study and LCF data from ref. 1 plotted versus time. Also plotted is the 815°C fast fracture strength of the composites tested in ref. 1.

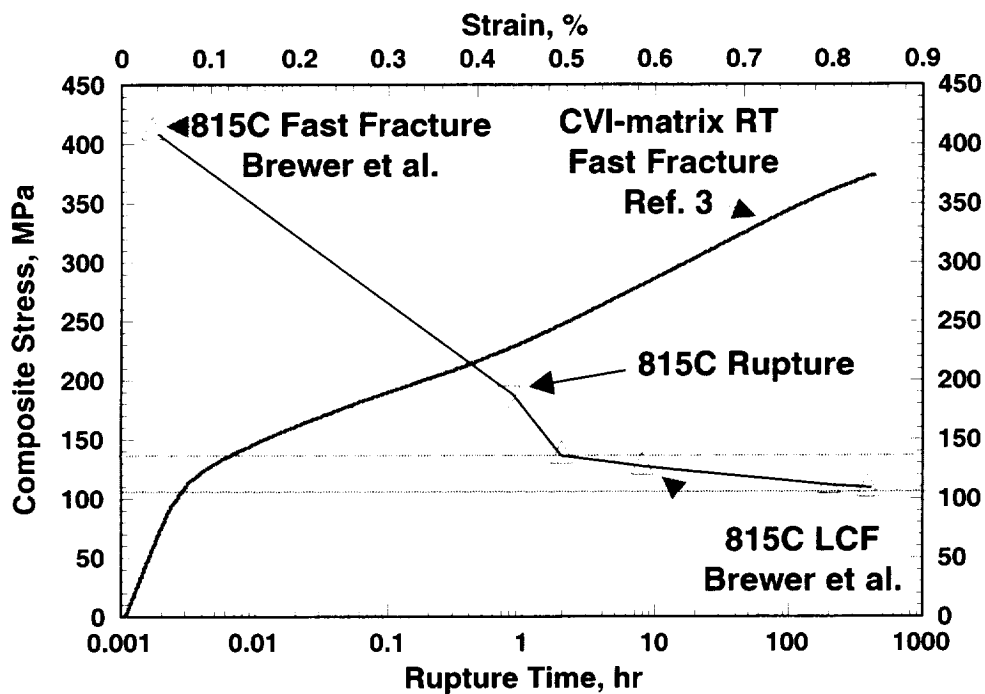
Figure 3.18: Room temperature and time dependent stress-rupture behavior of Hi-Nicalon, BN interphase, CVI SiC composites.
